## **Request for Qualifications LGJL Preservation**

**Construction Manager/  
General Contractor Services**

Jacob's Lane  
3450 Jacob's Lane  
Eugene, Oregon 97402

Laurel Gardens  
1775 West 12th Avenue  
Eugene, OR 97402

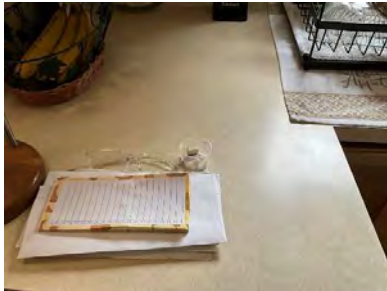
### Casework in Poor condition.

Countertop, Plastic Laminate  
Jacob's Lane Unit Interiors

Material is degraded. - AssetCALC ID: 8663571

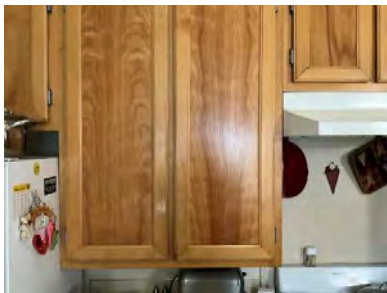
### Casework in Poor condition.

Cabinetry, Economy  
Jacob's Lane Unit Interiors

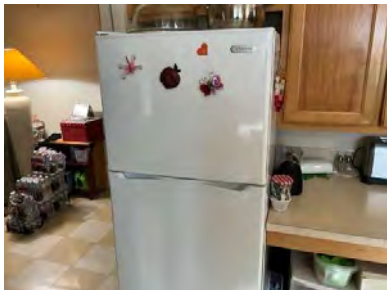
### Residential Appliances in Failed condition.

Refrigerator, 14 to 18 CF  
Jacob's Lane Unit Interiors

Appliance has been stripped. - AssetCALC ID: 8663549

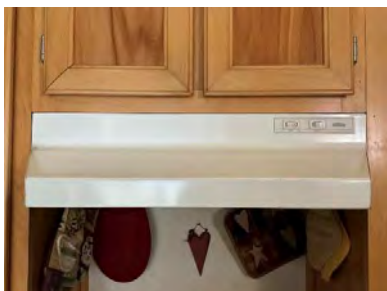
### Residential Appliances in Failed condition.

Range Hood  
Jacob's Lane Unit Interiors

Appliance has been stripped. - AssetCALC ID: 8663550

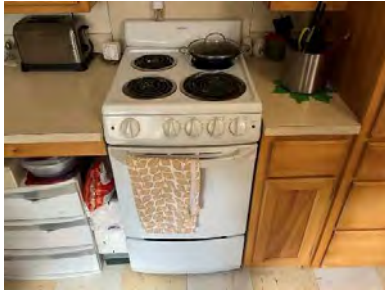
### Residential Appliances in Failed condition.

Electric Cooktop with Wall Oven  
Jacob's Lane Unit Interiors

Appliance has been stripped. - AssetCALC ID: 8663548

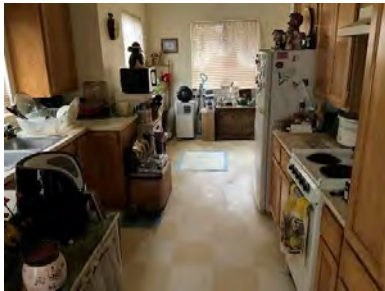
### Flooring in Poor condition.

Vinyl Tile (VCT)  
Jacob's Lane Office

Approximately half of the VCT within the units, on a unit-by-unit basis, needs to be fully replaced due to cracking, missing tiles, age or damage. - AssetCALC ID: 8663918

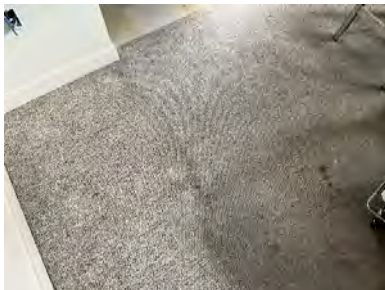
### Flooring in Poor condition.

Carpet, Residential  
Jacob's Lane Office

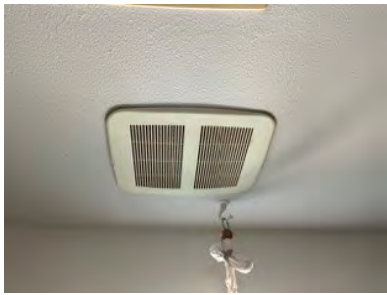
### Exhaust Fan in Failed Condition.

Residential Bathroom  
Laurel Gardens Apartment Bathroom

Does not work. - AssetCALC ID: 9502536

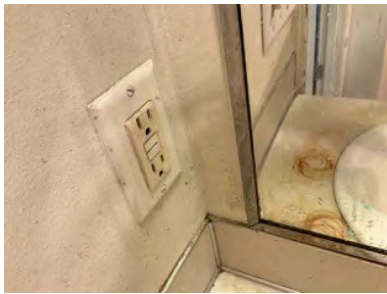
### Supplemental Components in Poor Condition.

Electrical Receptacle, Ground Fault Circuit  
Interrupter (GFCI), 15 to 20 AMP  
Laurel Gardens Apartment Bathroom

Doesn't work. - AssetCALC ID: 9502560

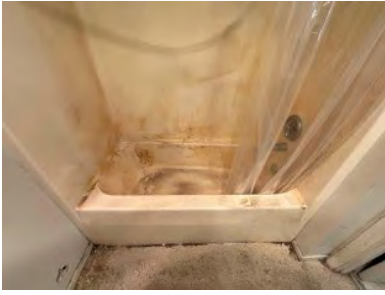
### Tub in Poor Condition.

Fiberglass, w/ Shower Enclosure  
Laurel Gardens Apartment Bathroom

Extremely poor condition. - AssetCALC ID: 9502573

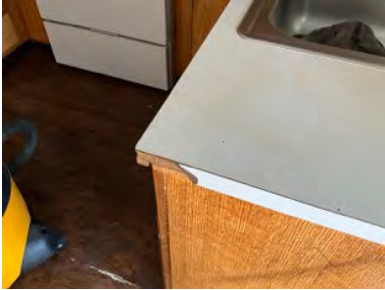
### Casework in Poor Condition.

Countertop, Plastic Laminate  
Laurel Gardens Apartment Kitchen

Needs repair. - AssetCALC ID: 9502562

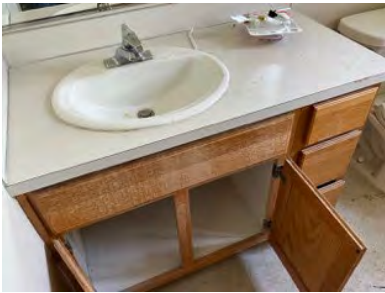
### Casework in Poor Condition.

Bathroom Vanity Cabinet, Wood w/ Cultured  
Marble Sink Top  
Laurel Gardens Apartment Bathroom

Missing doors or needs repair. - AssetCALC ID: 9502572

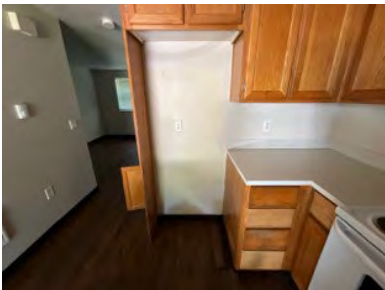
### Residential Appliances in Failed Condition.

Refrigerator, 14 to 18 CF  
Laurel Gardens Apartment Kitchen

Missing. - AssetCALC ID: 9502537

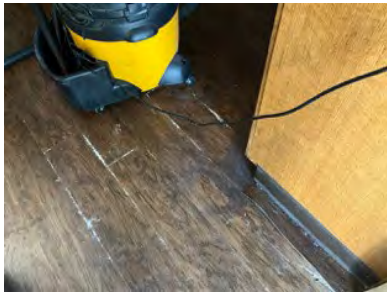
**Flooring in Failed Condition.**

Luxury Vinyl Tile (LVT)  
Laurel Gardens Apartment Kitchen

Dilapidated flooring. - AssetCALC ID: 9502557

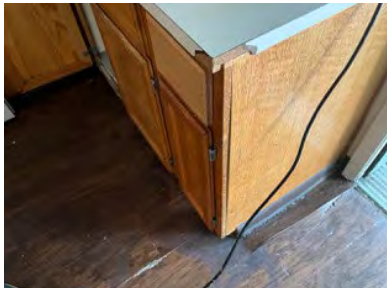
**Recommended Follow-up Study:  
Environmental, Analysis of  
Suspect Fungal Growth**

Environmental, Analysis of Suspect Fungal  
Growth  
Laurel Gardens

Microbial growth. Very strong smell. - AssetCALC ID: 9502538

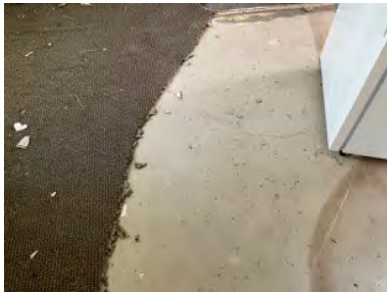
**Flooring in Failed Condition.**

Carpet, Residential  
Laurel Gardens Apartment Throughout

Dilapidated flooring. - AssetCALC ID: 9502587

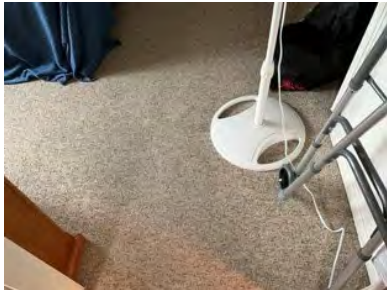
**Flooring in Poor Condition.**

Carpet, Residential  
Laurel Gardens Apartment Bedroom(s)

Dilapidated flooring. - AssetCALC ID: 9502596

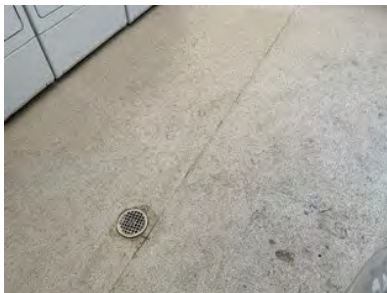
**Flooring in Poor Condition.**

Vinyl Sheetting  
Laurel Gardens Utility Rooms/Areas

Dilapidated flooring. - AssetCALC ID: 9495473

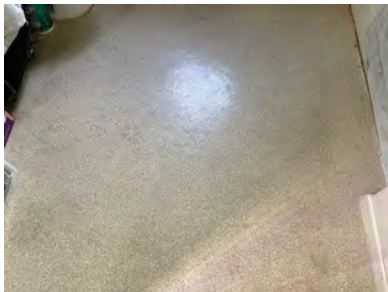
Flooring in Poor Condition.

Vinyl Sheeting  
Laurel Gardens Apartment Bathroom
